SALMONID HABITAT LIMITING FACTORS WATER RESOURCE INVENTORY AREAS 33 (LOWER) & 35 (MIDDLE) SNAKE WATERSHEDS, & LOWER SIX MILES OF THE PALOUSE RIVER

**Final Report
March 18, 2002**

By
Mike Kuttel, Jr.
Washington State Conservation Commission
P.O. Box 47721
Olympia, Washington 98504-7721

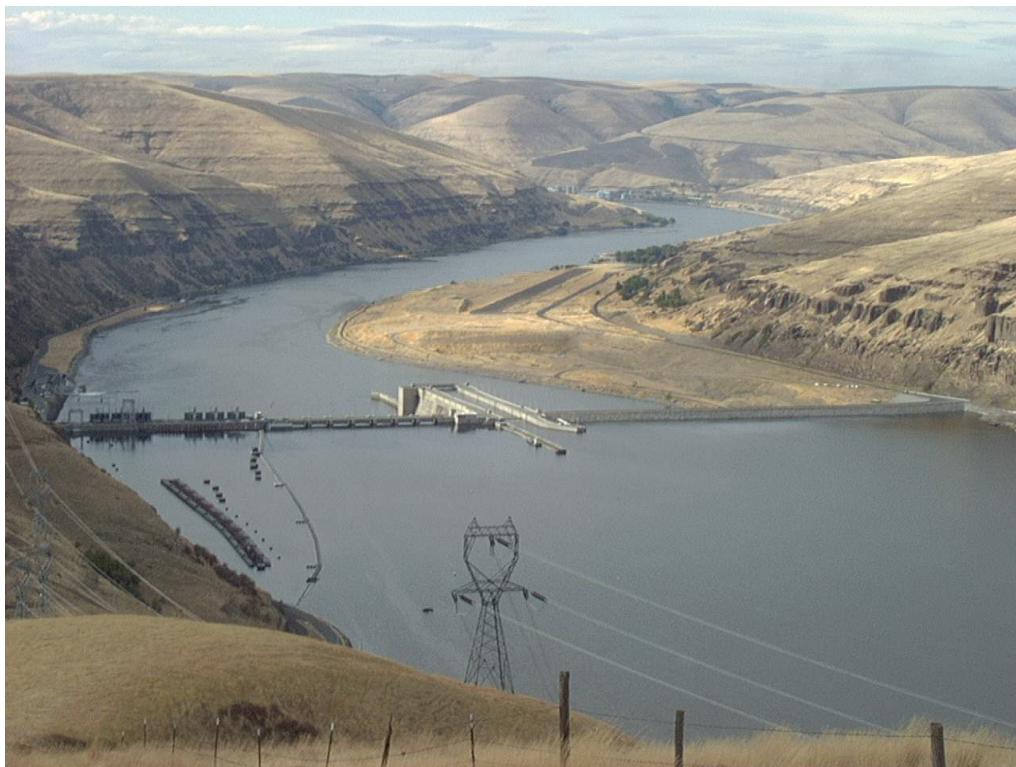
Figure 4. Lower Granite Dam RM 107 Snake River. Photographed September 2001.

Artificial obstructions including dams and culverts can block salmonid migration up and down streams. Depending on the location and longevity of the barrier, the negative effect may be limited to a portion of only one generation, or in extreme cases, the barrier may cause the extinction of an entire run of fish. Manmade structures that may hinder salmonid migration in WRIAs 33, 34, and 35 include concrete dams, gravel push-up dams, and failed culverts. Natural waterfalls are common in headwater areas within the Blue Mountains (See Figure 4).

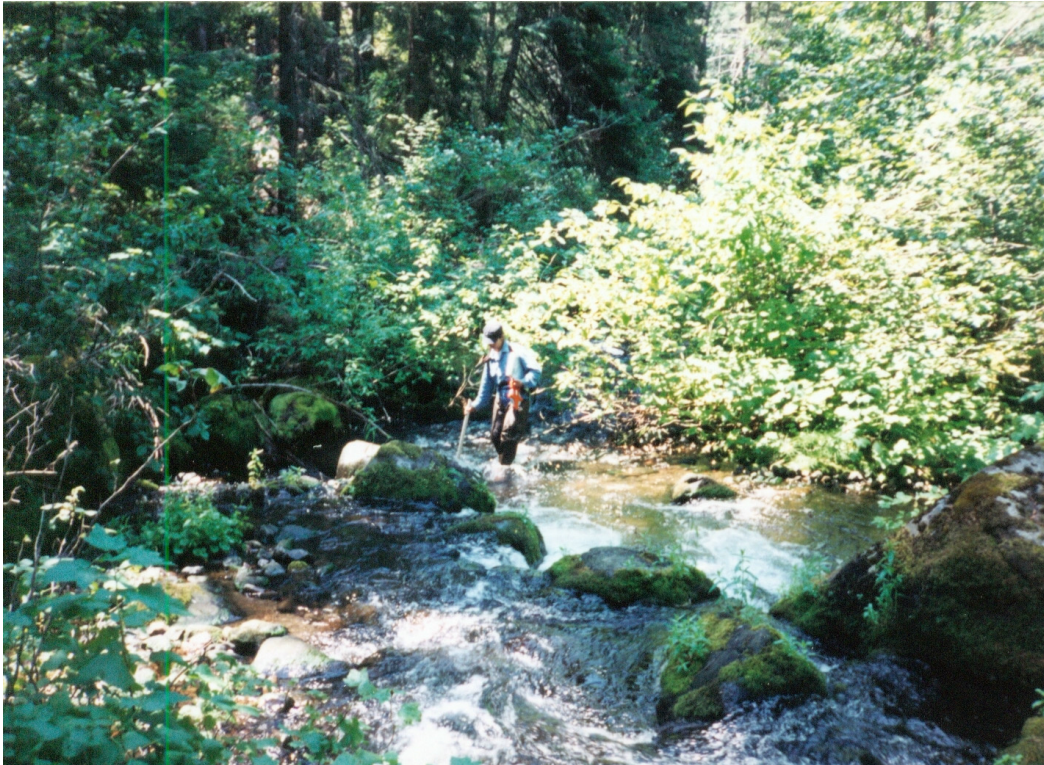
Figure 5. Riparian vegetation on lower First Creek showing bank stabilization, overhanging cover, and shading – July 1994. Photo courtesy of U.S. Forest Service, Pomeroy Ranger District.

Leaf litter falling into the stream is an important component of primary production within the aquatic community (Bisson and Bilby 2001), although Murphy (2001) asserts that production by aquatic plants and algae makes a larger contribution. Microinvertebrates (i.e. zooplankton) and macroinvertebrates (larval insects, aquatic snails, etc.) feed on the decomposing organic material. Fish and other animals in turn feed on the smaller organisms (Bisson and Bilby 2001). Mature trees in the riparian zone also provide important function when they are knocked into streams by floods, windthrow, or landslides. These woody materials are known as large woody debris (LWD). Large woody debris stabilizes streambeds and banks, captures spawning gravels, encourages pool formation, provides resting and hiding cover for salmonids, and creates habitat for insects and other forage important to salmonids (Bilby and Bisson 2001). Finally vegetation within the riparian zone filters soil and pollutants from stormwater runoff (Knutson and Naef 1997, Welch *et al.* 2001) and reduces flood damage by slowing down flood waters, thereby dissipating energy and capturing soil carried in the flood waters (Naiman *et al.* 2001) (See Figure 5).

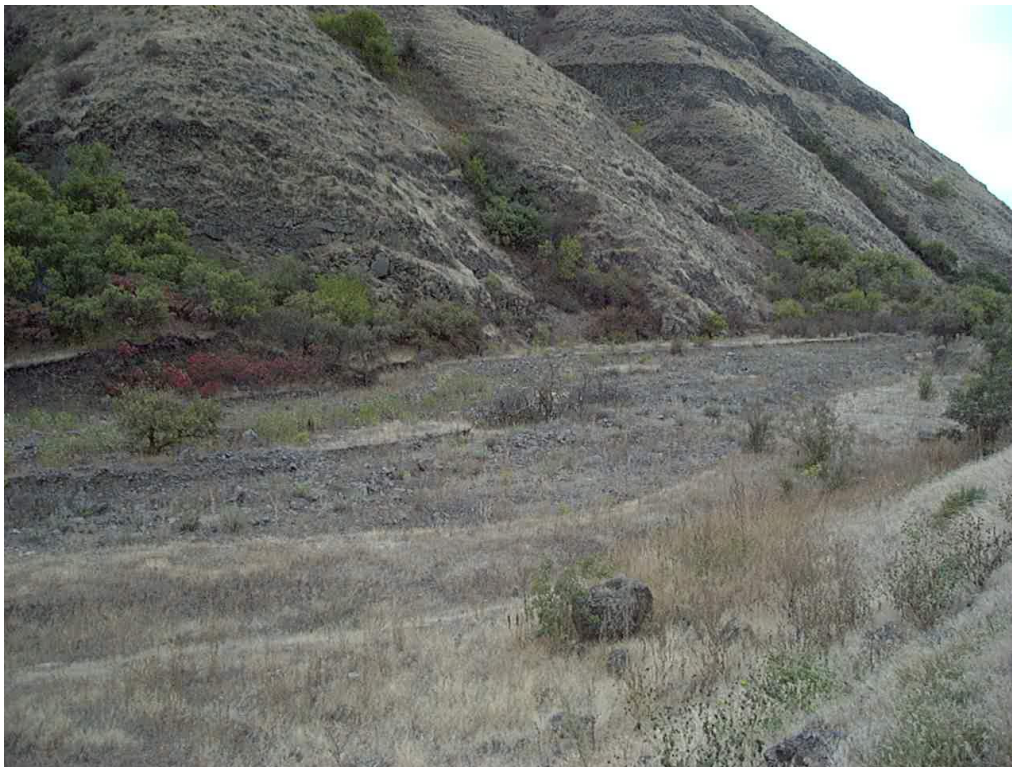
Figure 6. Braided stream reach on Couse Creek above RM 2. Photographed October 2001.

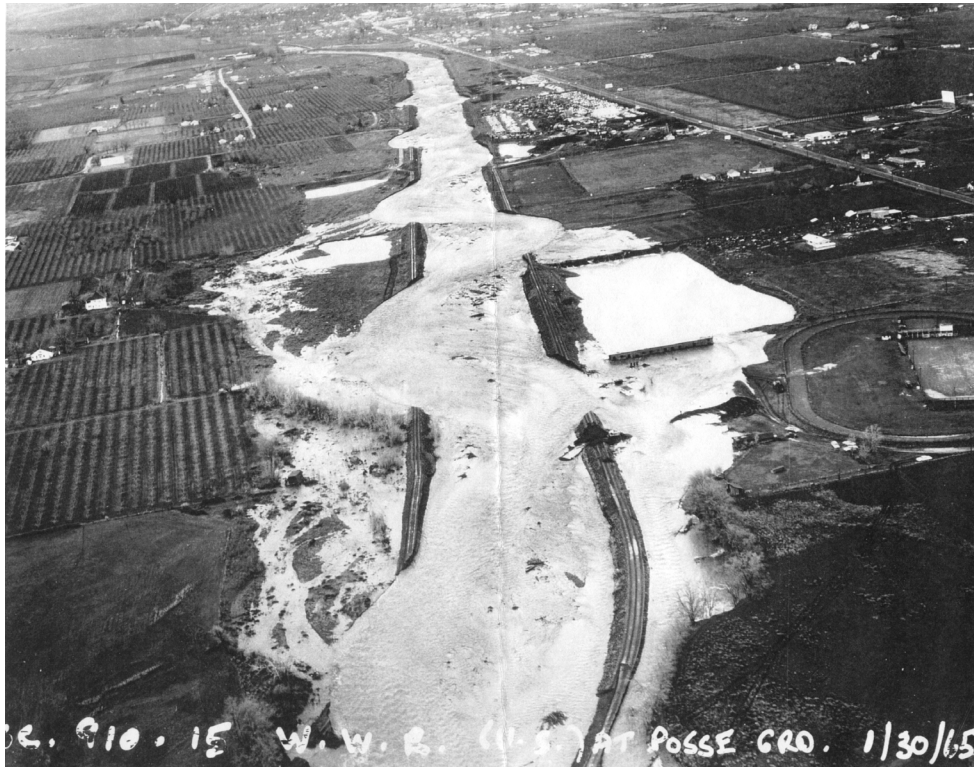
Figure 7. Walla Walla River downstream from Milton Freewater, OR 1965. Floodwaters burst through the dikes attempting to reestablish a meandering channel and reclaim the floodplain. Photo courtesy of U.S. Army Corps of Engineers, Walla Walla District.

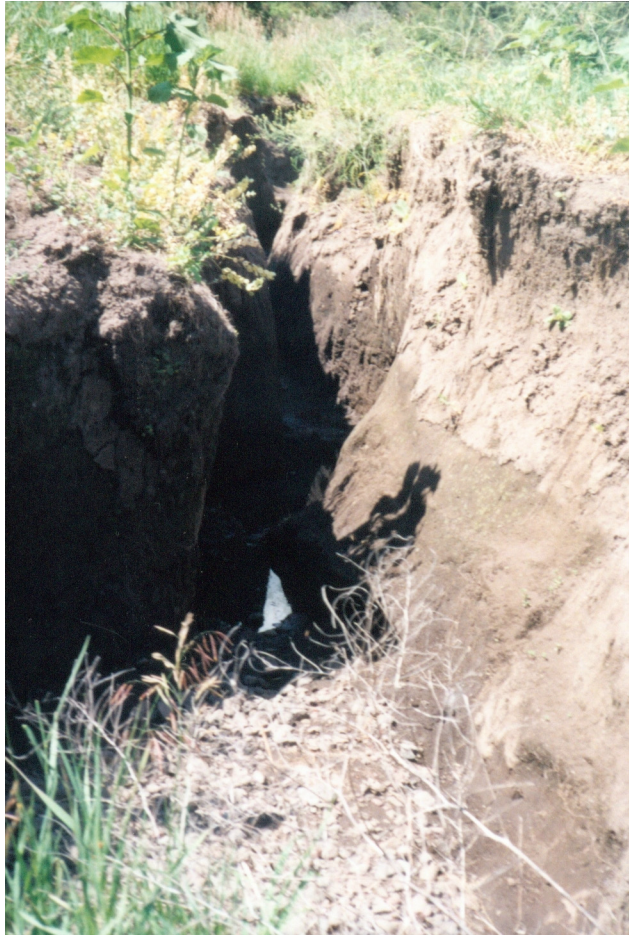
Figure 8. Channel incision on Lower Lick Creek, July 1996. Photo courtesy of U.S. Forest Service, Pomeroy Ranger District.

The width/depth ratio refers to the average width of the river channel at a given cross-section divided by the average depth at that same cross-section. In other words, it determines if the channel is wide and shallow (high width/depth ratio) or narrow and deep (low width/depth ratio). In general, a narrow deep channel is more favorable to salmonids than a wide shallow channel. Deep water provides hiding cover and maintains cool water temperatures, while shallow water provides little or no cover (depending upon the life stage) and tends to gather heat with an expansive surface area exposed to the sun. The width/depth ratio also provides clues about a river's current state of channel evolution. A low width/depth ratio indicates a stable channel that has reached the end point of channel evolution, or possibly an unstable channel that is downcutting rapidly in response to channel disturbances elsewhere within the watershed. Conversely, a very high width/depth ratio usually indicates unstable streambanks and rapid deposition of sediments. This situation might naturally occur at a river outlet or delta area, or it could be a response to channel disturbances upstream or downstream (Rosgen 1996) (See Figure 8).

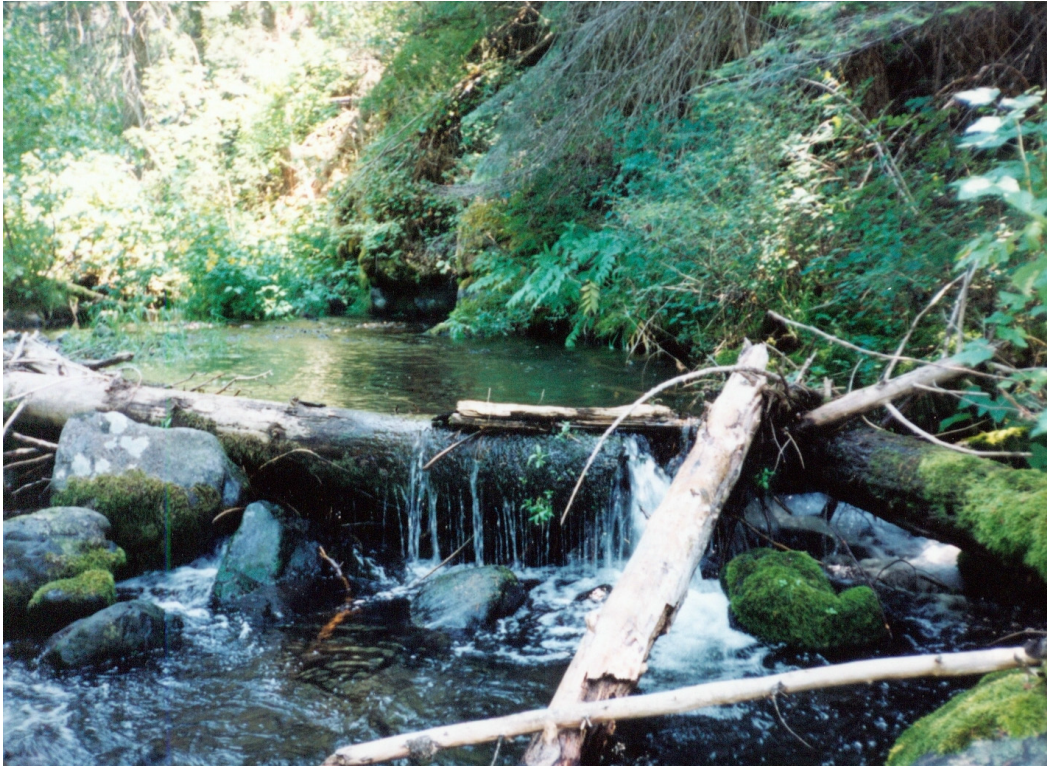
Figure 10. Large woody debris providing complex instream cover on lower First Creek – July 1994. Photo courtesy of U.S. Forest Service, Pomeroy Ranger District.

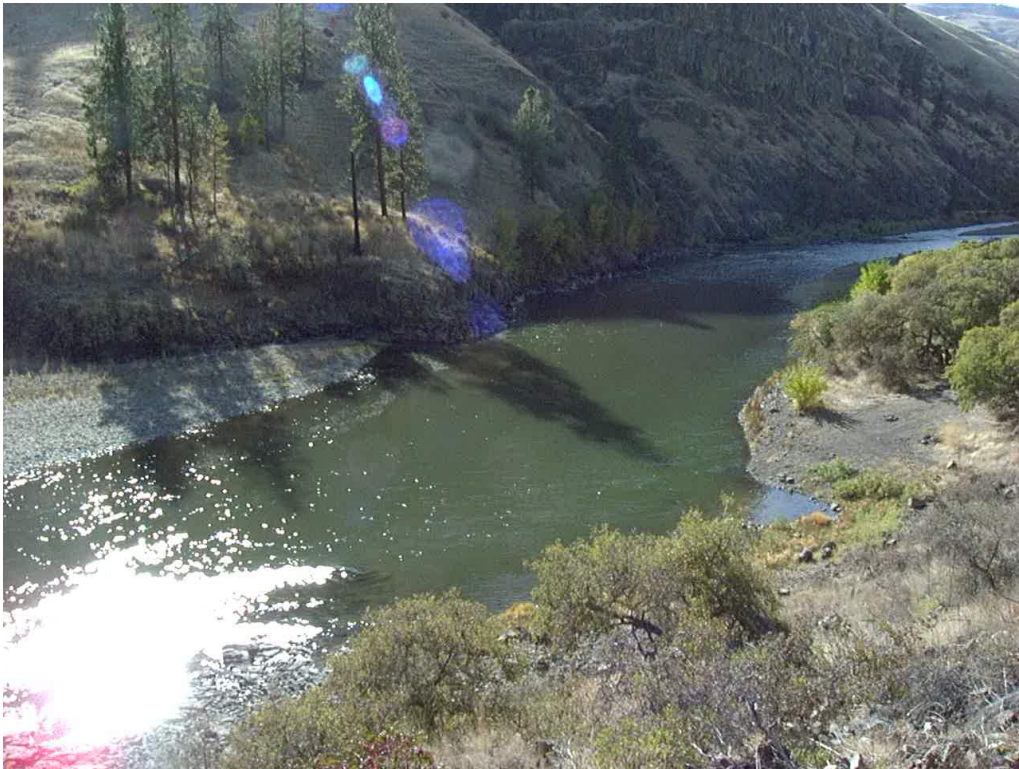
Figure 11. Very large and deep pool on Grande Ronde River upstream from Schumaker Creek. Photographed October 2001.

Important features of pools are size, depth, and cover (instream and overhead). Generally speaking, the more size, depth, and cover that are present, the higher the quality of the pool. Large-deep pools with lots of cover provide many hiding areas, ample forage, and cool water temperatures. An abundance of pools interspersed with riffles combine to create ideal salmonid habitat (See Figure 11).

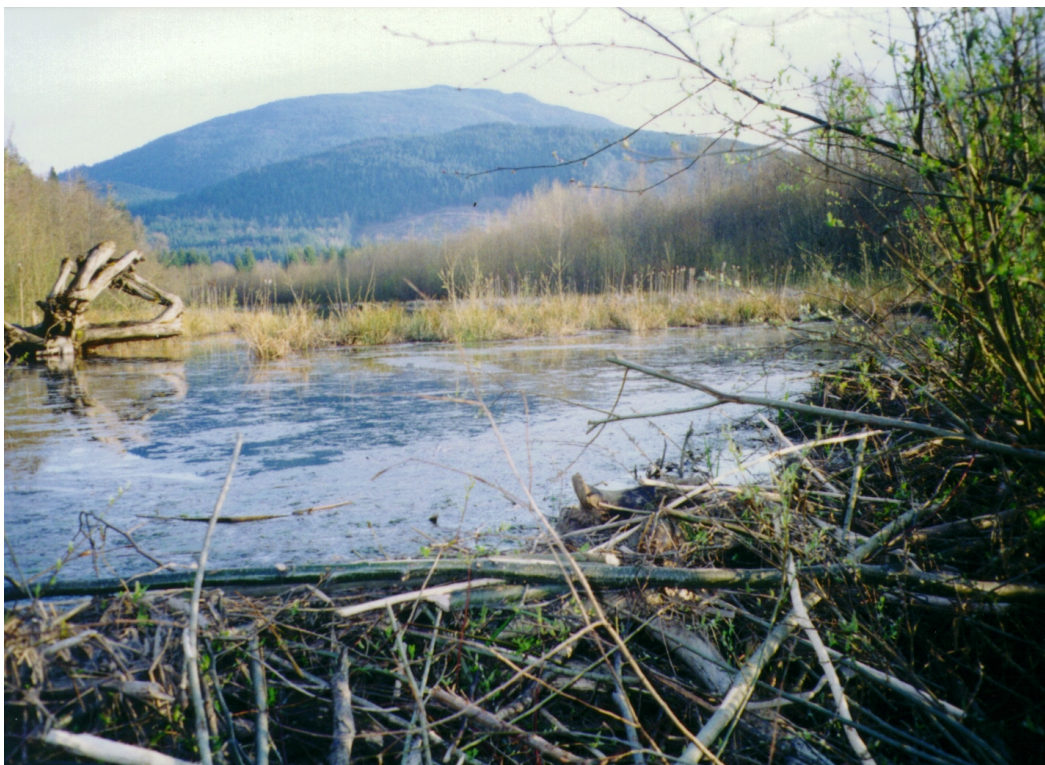
Figure 12. Beaver ponds provide excellent off-channel rearing habitat for salmonids. Today beaver populations are depressed in southeast Washington. Photo was taken in western Washington.

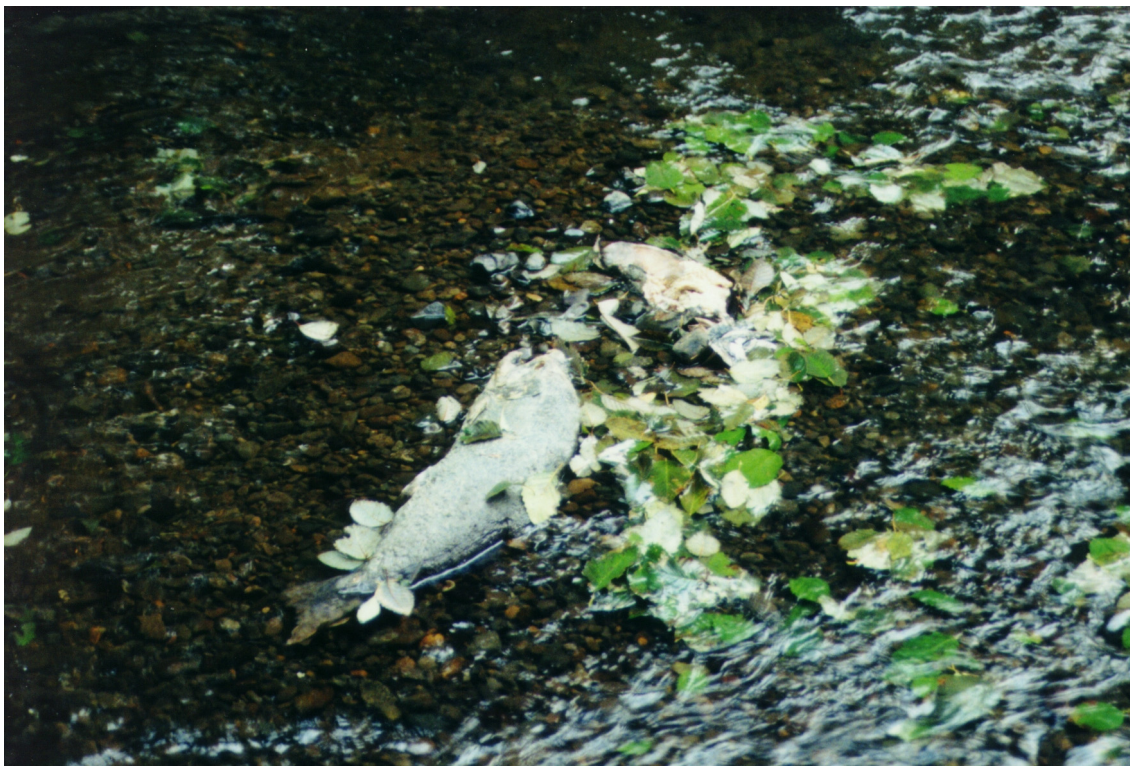
Figure 13. Decomposing anadromous fish carcasses provide ocean-derived nutrients to freshwater ecosystems. Photo taken in western Washington.

Biological processes include the presence of introduced plant or animal species that may have a negative effect on salmonids (i.e. reed canary grass, brook trout, smallmouth bass) as well as the absence of native species that were historically present such as beaver and coho salmon. Introduced plants and noxious weeds can out-compete native vegetation, reducing the quality of riparian plant communities (Knutson and Naef 1997) and increasing the frequency and/or intensity of fires. Introduced fish species may out-compete, hybridize with, or eat native salmonids. Removal of species can disrupt ecosystem functions (McClain *et al.* 2001). For example, beaver were historically more numerous in southeast Washington. Beaver ponds are excellent salmonid rearing habitat and they gradually release water to streams, helping to maintain summer flows (Lichatowich 1999). Anadromous salmonids returning from the ocean are a valuable source of nutrients to watersheds which are often nutrient limited (McClain *et al.* 2001). Nutrients from decomposing salmon carcasses are a critical component of aquatic (Bisson and Bilby 2001) and terrestrial food webs (Reeves *et al.* 2001). Adult anadromous fish escapements are severely below historic levels in southeast Washington streams (Mendel 2001, personal communication) (See Figure 13).

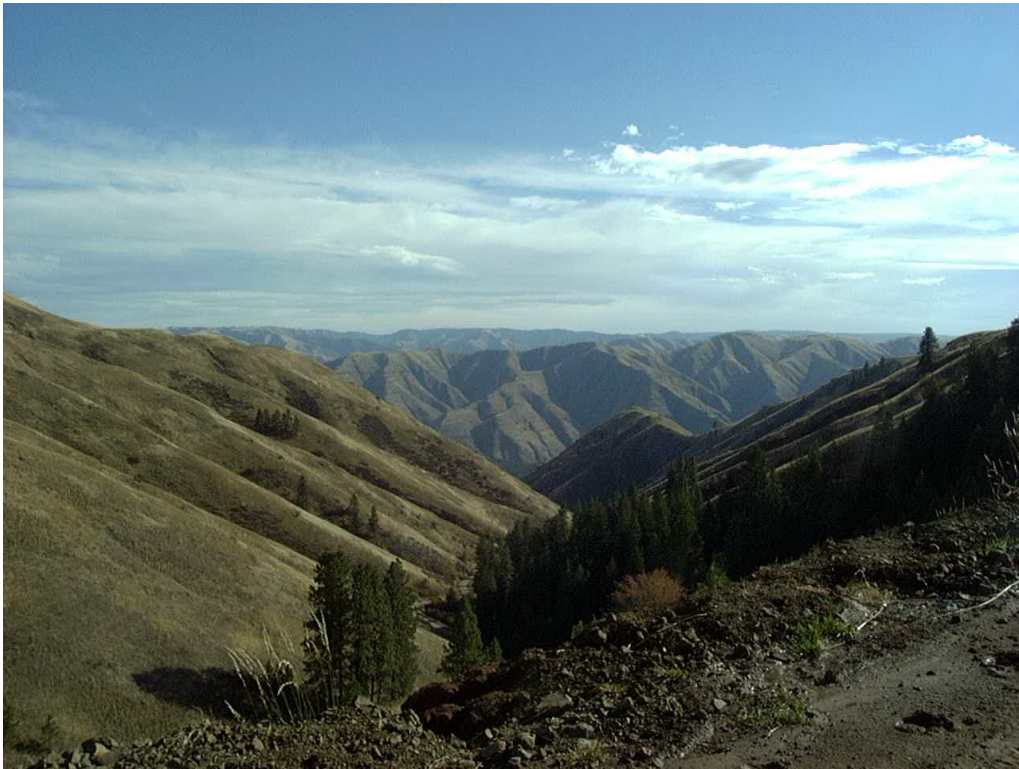
Figure 15. Schumaker Creek Canyon demonstrating steep gradient. Photographed October 16, 2001.

These streams have very steep gradients, with the exception of lower Joseph Creek (Kuttel 2001b). They would be classified as “Aa+” or “A” streams under the Rosgen stream classification system (Rosgen 1996). Floodplains would not be expected to occur (See Figure 15).

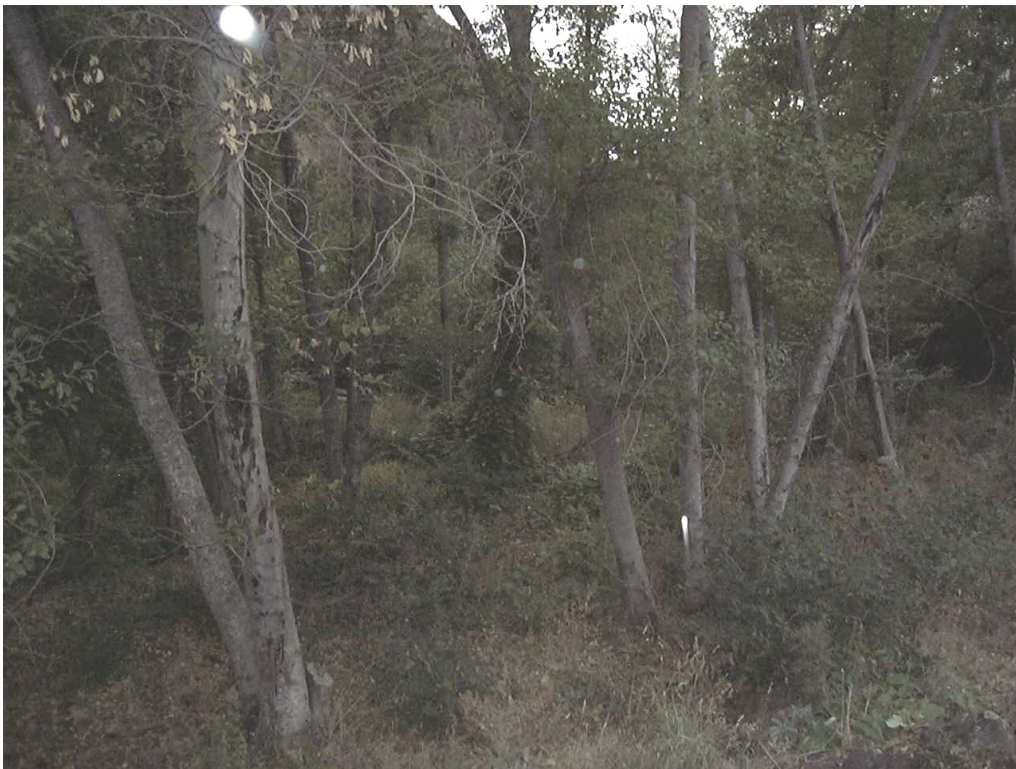
Figure 16. Riparian buffer on Couse Creek downstream from RM 1.6. Photographed October 2001.

Gulch (RM 3.1) the riparian buffer was nearly nonexistent. Forbs, grasses, sedges, and rushes were the dominant plants. Shading averaged only 10% (Mendel 2001, unpublished work). The damage was likely caused by the 1996-97 floods. A patchy buffer of scattered trees and shrubs is present from Montgomery Gulch upstream (Mendel 2001, personal communication, Mendel *et al.* 2001).

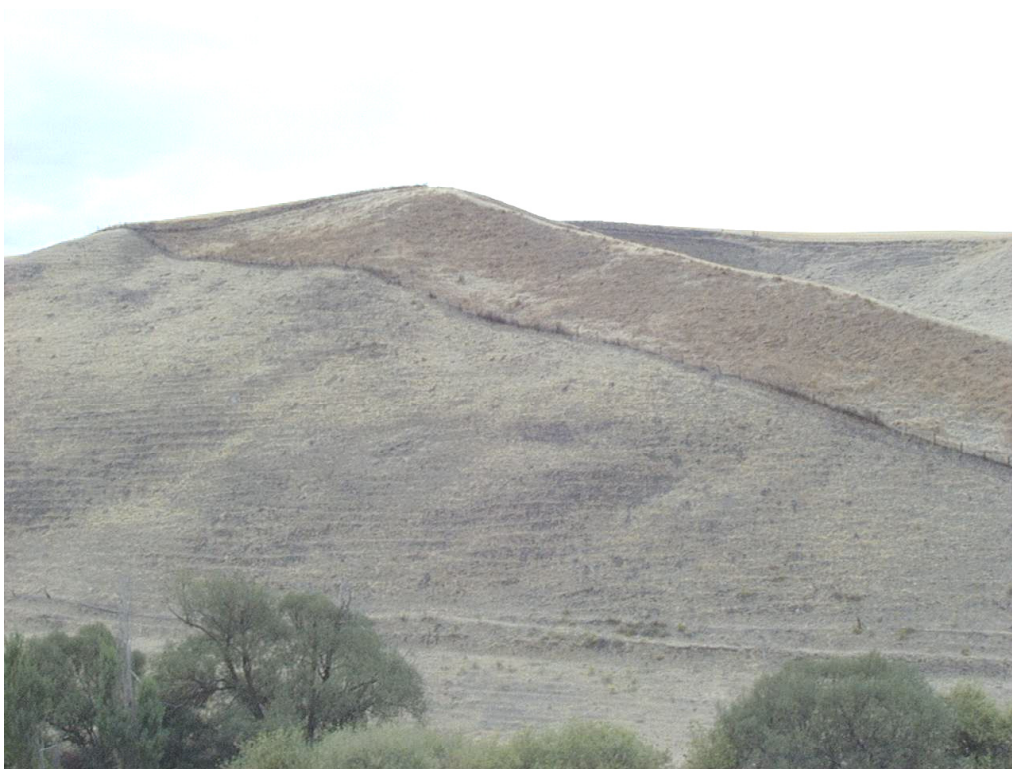
Figure 17. Rangeland along Ben Day Creek (tributary of Meadow Creek) damaged by heavy grazing. Photographed September 2001.

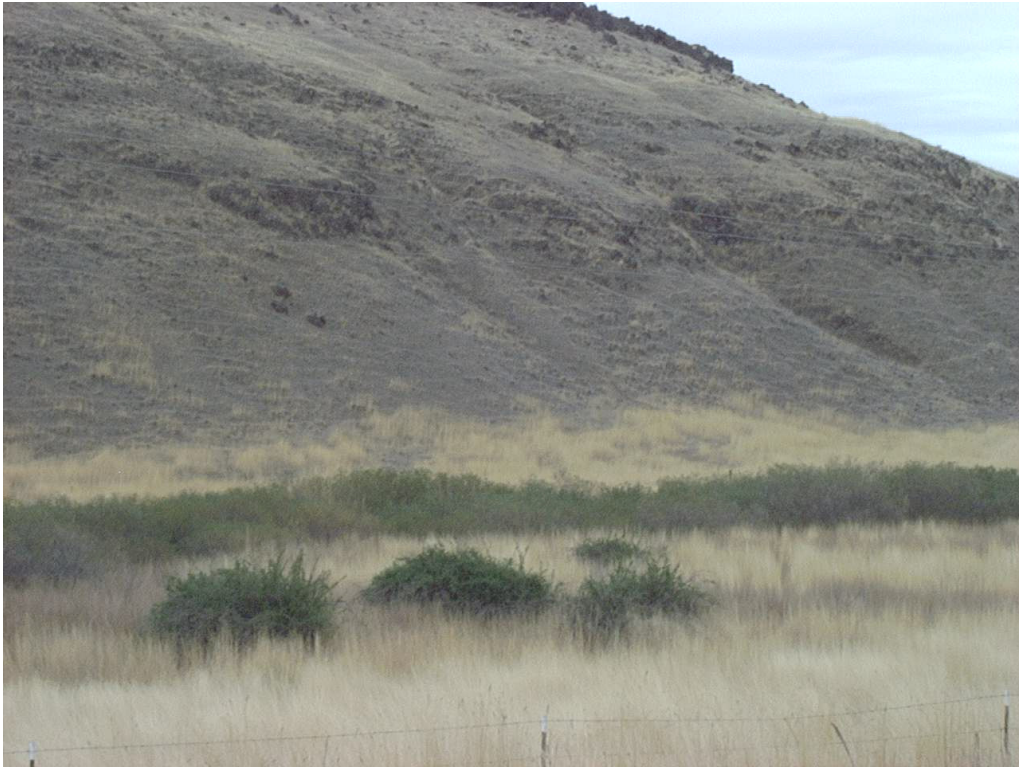
Figure 18. Riparian vegetation along lower Meadow Creek (about river mile 1). Photographed 9/26/2001

Woody shrubs and a few scattered willows dominate riparian vegetation on Meadow Creek from the mouth upstream to Ben Day Creek (Kuttel 2001b). False Indigo (an introduced species) has taken over the riparian zone of Meadow Creek (TAG 2001, personal communication). Forbs were the dominant riparian vegetation from RM 7.2 to RM 8.3. Some grazed pasture and a few deciduous trees with an average height of 10' and maximum height of 27.5' were also present. The buffer averaged 7.5' in width and provided 17% shading (Mendel 2001, unpublished work). Cattle grazing and dryland farming are both practiced on the valley floor. Wheat is farmed to the edge of the terrace just downstream from the forks (Kuttel 2001b). Forbs and shrubs were the primary riparian vegetation from RM 12.8 to RM 13.9. The shrubs ranged from 4' to 7' tall and provided average shading of 21%. The buffer averaged 4' in width (Mendel 2001, unpublished work). Grasses, sedges, rushes, and cattails dominated the riparian zones of both forks of Meadow Creek. Small patches of mature deciduous trees were present at the end of the county road on South Meadow Creek and the lower half mile of North Meadow Creek (Kuttel 2001b). Grazed pasture, grasses and forbs, and some deciduous trees were present from the mouth of North Meadow Creek to RM 1.8. The buffer averaged 5' in width with trees 8' to 24' in height. Shading averaged 45% (Mendel 2001, unpublished work) (See Figure 18).

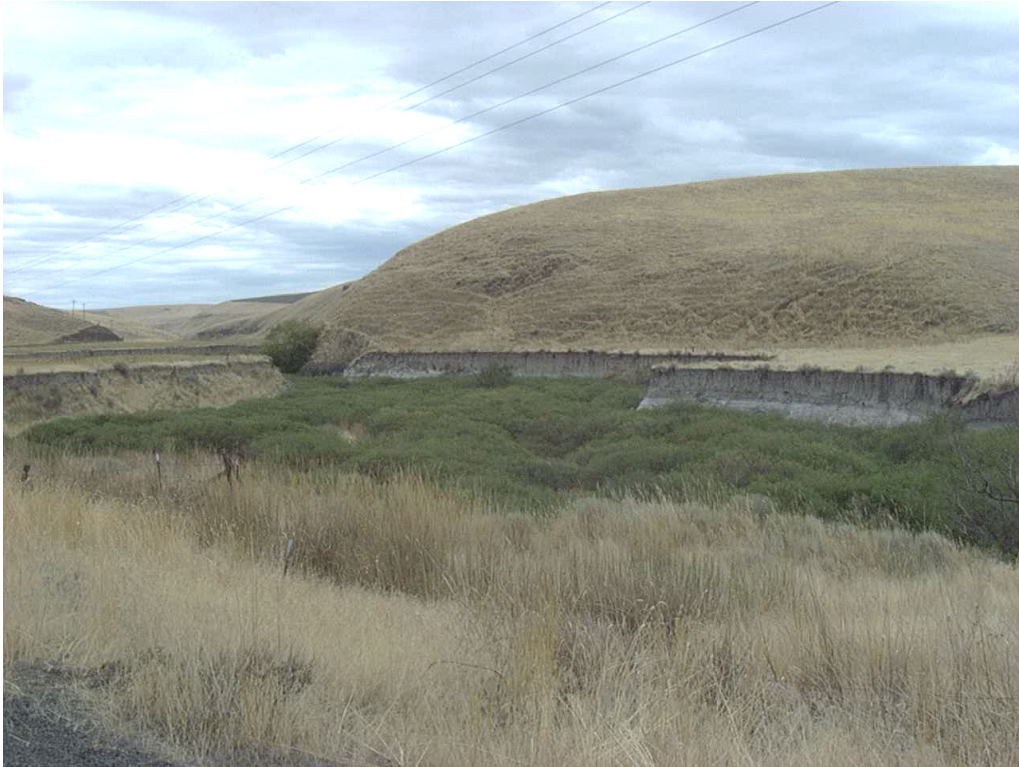
Figure 19. Channel incision on lower Meadow Creek (about river mile 2). Photographed 9/26/2001.

Channel incision up to 30 feet deep had led to abandonment of the historic floodplain. A new floodplain is forming in portions of the channel that have widened from a Rosgen “G” gully channel to an “F” channel. These new floodplains are far smaller than the terrace that formerly functioned as the floodplain (Kuttel 2001b). Portions of North Meadow Creek from the mouth to RM 1.8 had access to a floodplain (Mendel 2001, unpublished work) (See Figure 19).

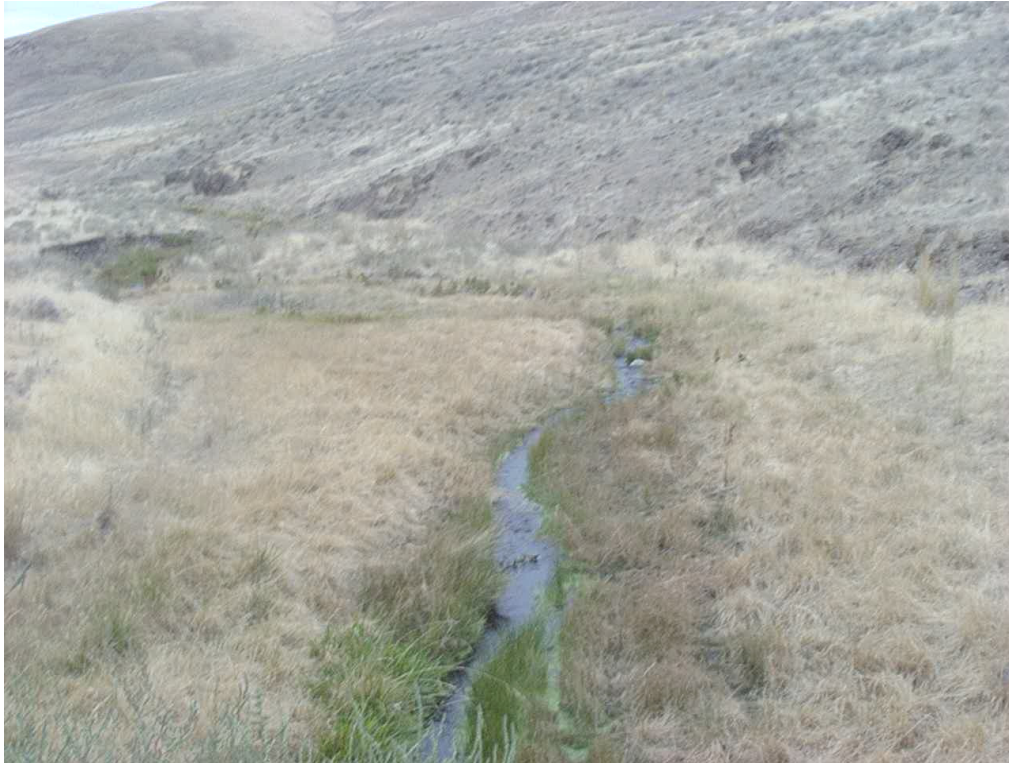
Figure 20. South Deadman Creek downstream from South Deadman Road crossing. Photographed 9/26/2001.

unpublished work). A large gallery of mature deciduous trees was present at the farmstead, but grazing was very heavy from the farmstead upstream to Kirby-Mayview Road. Sagebrush and sparse grass were the dominant vegetation. A very impressive collection of mature deciduous trees was located along North Deadman Creek from the Mayview Grange upstream to the vicinity of Chappell Hill Road. The surrounding area was in production of dryland crops, but a dense buffer was being maintained along this reach. This buffer may be a good example of the historic riparian plant community. Little or no woody riparian vegetation was present along South Deadman Creek, but a few mature deciduous trees were scattered along the stream adjacent to Guild City-Mayview Road (Kuttel 2001b). Forbs, grasses, sedges, and rushes were the primary riparian plants along South Deadman Creek from RM 0.8 to RM 1.5. The buffer averaged 4' in width with no shading (Mendel 2001, unpublished work) (See Figure 20).

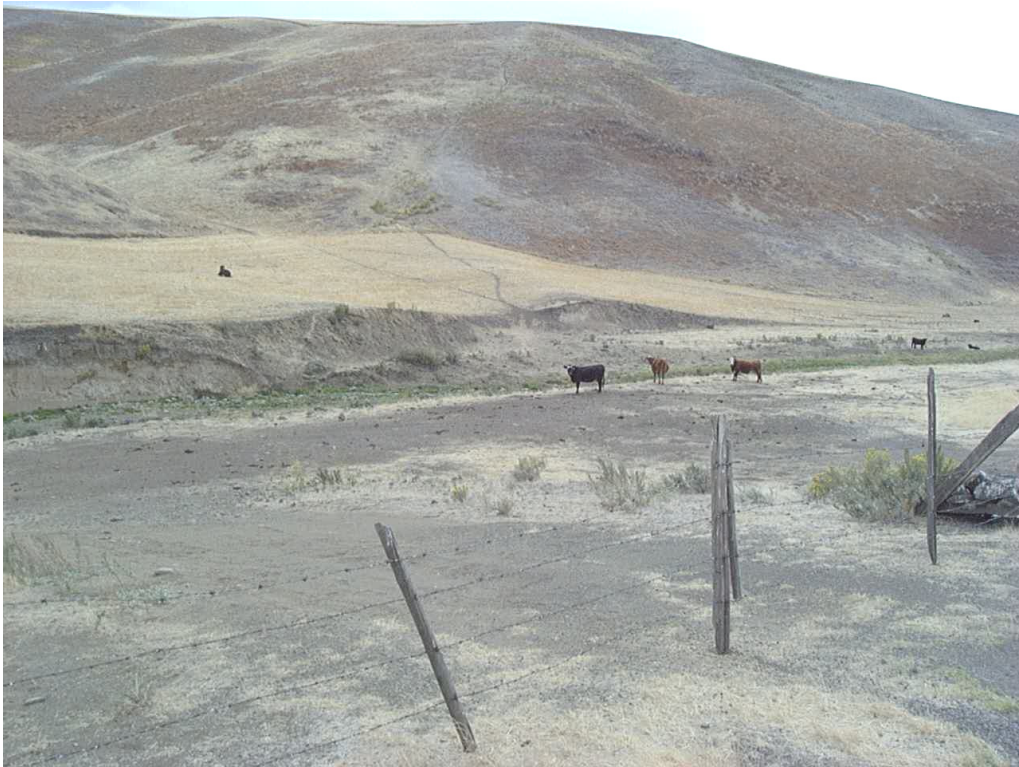
Figure 21. Feedlot along North Deadman Creek. Photographed 9/26/2001.

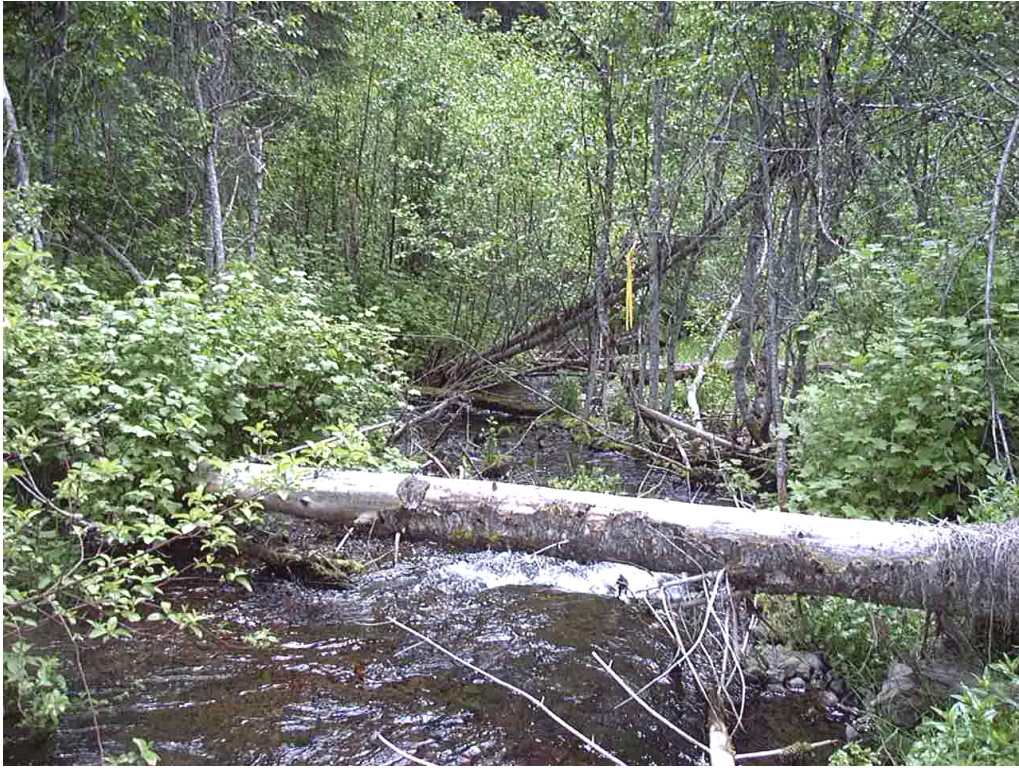
Figure 22. Tucannon River riparian vegetation at Sheep Creek. Photographed 6/14/2001.

Riparian vegetation was assessed in 1994. A mixture of grand fir and alder in the small tree/small pole size class dominated riparian vegetation on this reach of the Tucannon River. Canopy cover averaged 54% (See Figure 22). The Bear Creek riparian zone was dominated by Douglas-fir and Pacific yew and provided an average of 21% canopy cover. Riparian vegetation along the lower 0.5 mile of Sheep Creek was dominated by grand fir and alder that provided an average canopy cover of 20%. The riparian zone along Panjab, Meadow, and Turkey Creeks was dominated by large grand fir and alder with some maple on upper Panjab Creek. Average canopy cover was 56%, 62%, and 48% for Panjab, Meadow, and Turkey Creeks respectively (Columbia Conservation District 1997). All of Panjab Creek from Meadow Creek (RM 1.9) upstream is located within the Wenaha-Tucannon Wilderness Area. No grazing has occurred in the Wilderness portion of Panjab Creek since the early 1950s and logging last took place in 1978. A vast network of trails is heavily used by pack animals (Forest Service 1992h, unpublished work). The lower end of Meadow Creek was part of the Upper Tucannon grazing allotment, which averaged 70 head of cattle. Damage caused by grazing was minimal during 1992 surveys (Forest Service 1992f, unpublished work), the last year grazing was allowed (Groat 2001, personal communication). Recreation is a major activity on public lands in the Tucannon Watershed. Visitors spend an estimated 400,000 "Recreation Visitor Days" per year on Forest Service lands (Forest Service 1994). Twenty-seven campgrounds, 16 on USFS lands, and 11 on the Wooten Wildlife Area were located along the Tucannon River. Riparian vegetation was damaged or cleared to make room for campsites and parking (Johnson 1995). Logs and dead wood were cut for firewood, while small brush was cut for roasting sticks. Trees were damaged by being used to hang lanterns and other items and as stock hitching posts (Columbia Conservation District 1997). Some of the campgrounds were either eliminated or relocated to repair the existing riparian damage and prevent future damage (Johnson 1995). As of 2001, WDFW maintained seven campgrounds and the Forest Service managed five campgrounds (Northwest Power Planning Council 2001e).

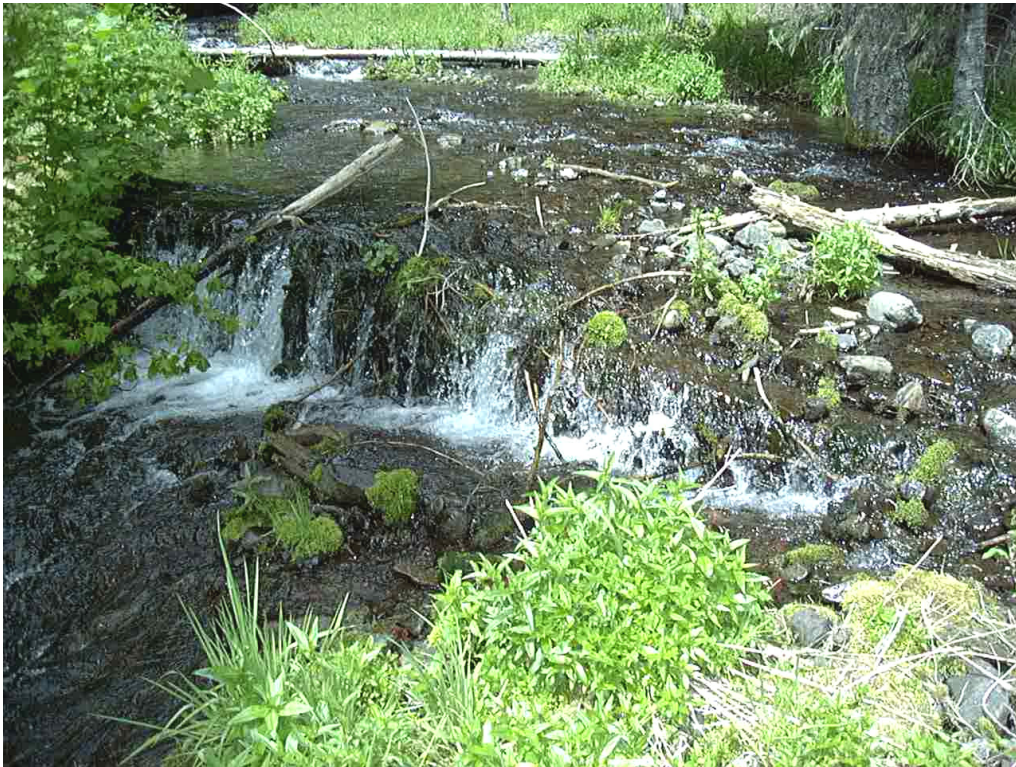
Figure 23. Log in Sheep Creek stabilizing streambed. Photographed 6/14/2001.

Bear, Sheep, and Cold Creeks all had abundant levels of LWD in 1992 with 83, 298, and 238 pieces per mile respectively. LWD was also plentiful on Panjab Creek (212 pieces per mile), Turkey Creek (232 pieces per mile), and Meadow Creek (246 pieces per mile). The Tucannon River had 52 pieces of LWD per mile in 1997 (Forest Service 1998, unpublished work) (See Figure 23).

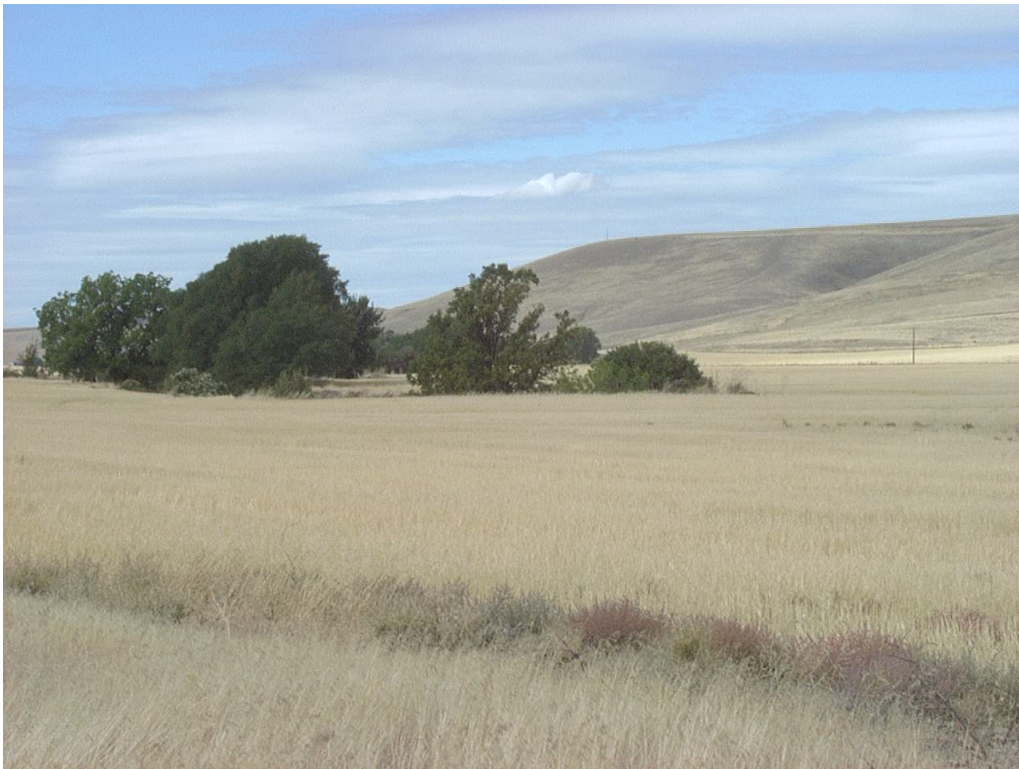
Figure 24. Farming to the edge of terrace on Pataha Creek about 1/4 mile downstream from Dodge. Note the stream is hidden in the incised channel marked by trees. Photographed 9/26/2001.

An extensive wetland complex was present near Dodge until the early 1900s when a local farmer channelized Pataha Creek to drain the wetlands. The channel modification coupled with conversion of thousands of acres of perennial grasslands to dryland wheat production led to rapid downcutting throughout the length of the stream channel. The historic floodplain became a terrace which no longer had a water table to support riparian vegetation (Pomeroy Conservation District 1998) (See Figure 24).

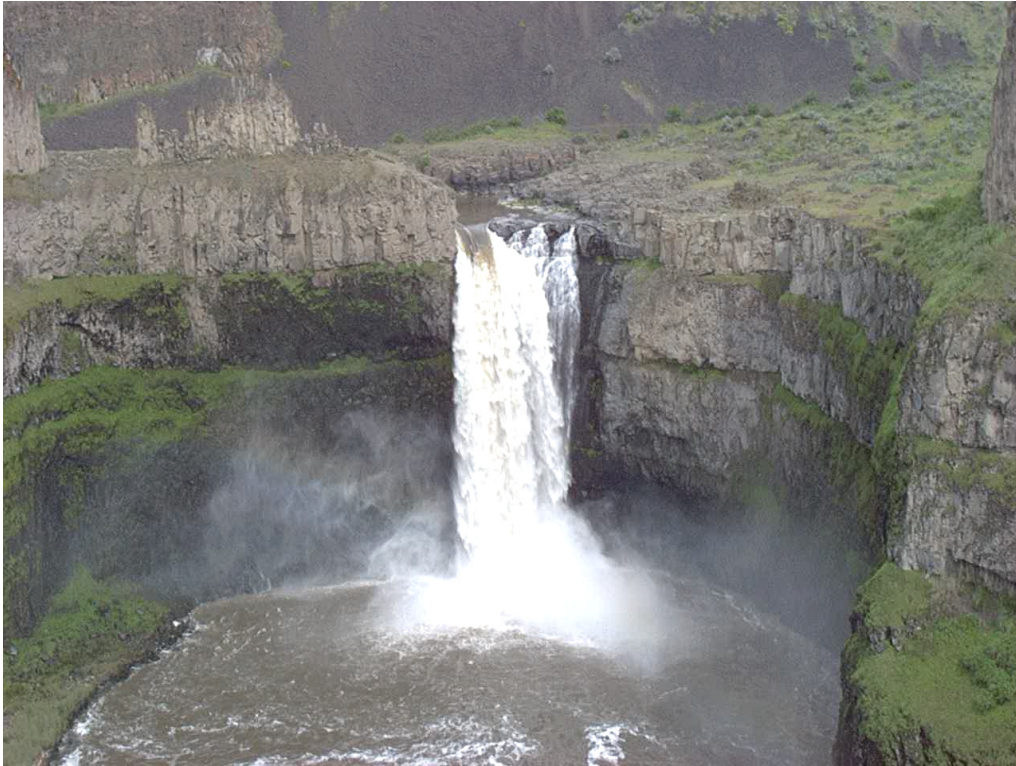
Figure 27. Palouse Falls. Photographed May 2001.

Palouse Falls (RM 6) at about 185 feet in height (USDA Soil Conservation Service *et al.* 1978) is a complete barrier to anadromous fish passage.
